Manhole Inspection Summary

Manhole # S08AA2003MH

Insp Date: **7/10/06 11:38 AM**

Location Address: **6837 Reisterstown Rd**

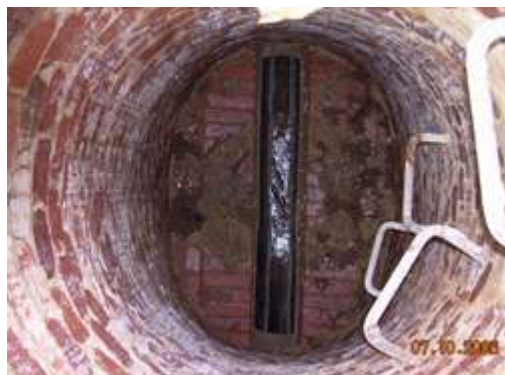
Top View

Bench ☒ Exists Material: **Brick** ☐ Parged ☒ **Debris** (not Condition related)

Surcharge ☒ **Evidence Of Surcharge** Depth: **1** (ft.) ☐ Active Surcharge Present

Bench debris

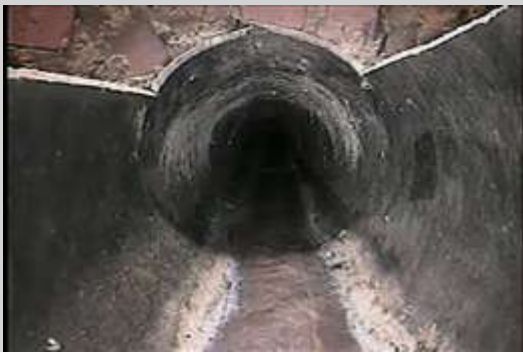
8 in. Circular Gravity Sewer Pipe Out @ 12 O'Clock

Pipe Material: **Unknown** ☒ Pipe Lined

Invert Depth: **8.08** (ft.) Flow Characteristics: **Slow**

Deposits: ☒ None ☐ Mud ☐ Sludge ☐ Debris ☐ Grease

Infiltration: **None** Pipe Seal Cond: **Unknown**

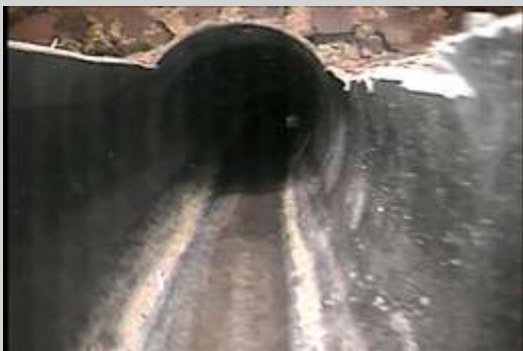
8 in. Circular Gravity Sewer Pipe In @ 6 O'Clock

Pipe Material: **Unknown** ☒ Pipe Lined

Invert Depth: **8.04** (ft.) Flow Characteristics: **Slow**

Deposits: ☒ None ☐ Mud ☐ Sludge ☐ Debris ☐ Grease

Infiltration: **None** Pipe Seal Cond: **Unknown**
